Manhole Inspection Summary

Manhole # S39S__020MH

Insp Date: **10/17/08 11:20 AM**

Location Address: **key highway**

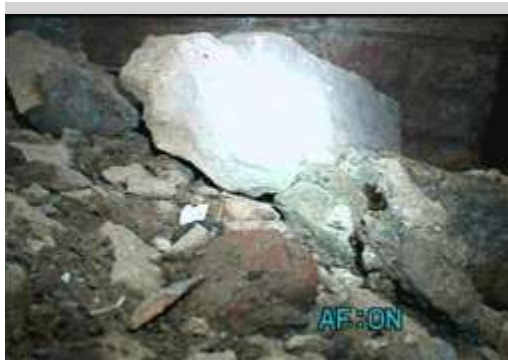
Defect 3

Condition: ☐ Sound ☐ Cracked ☐ Root Intrusion ☐ Deteriorated ☐ Leaks ☒ Debris

bench debris

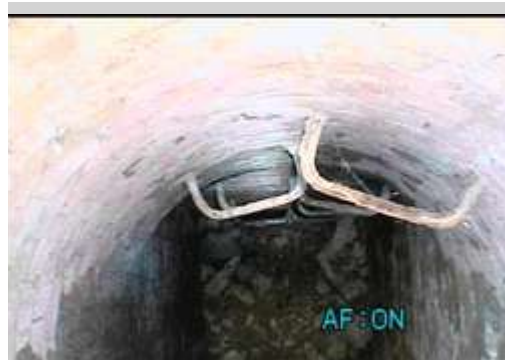
Defect 2

Steps Count: **8** Missing: **1** ☒ Corroded

cor. steps/missing 1st step

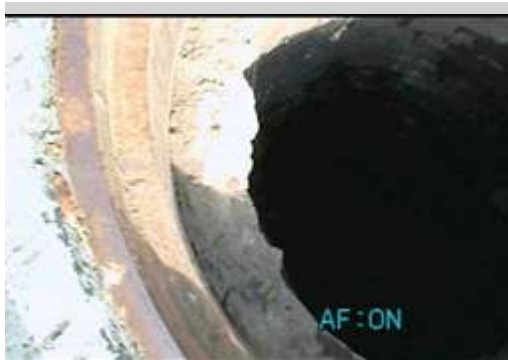
Defect 1

Frame Offset: **3.5** (in.) Condition: ☒ Sound ☐ Cracked ☐ Leaks

offset

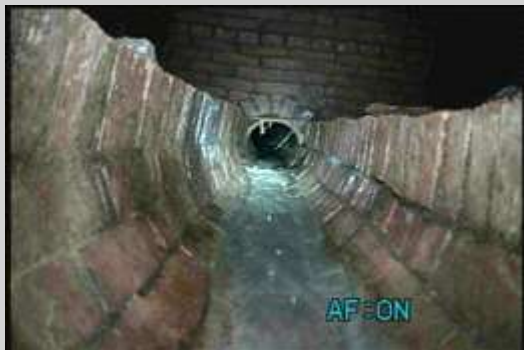
12 O'Clock Outflow

10 in. Circular Gravity Sewer
Pipe Out @ 12 O'Clock

pipe under ledge cant get better pic

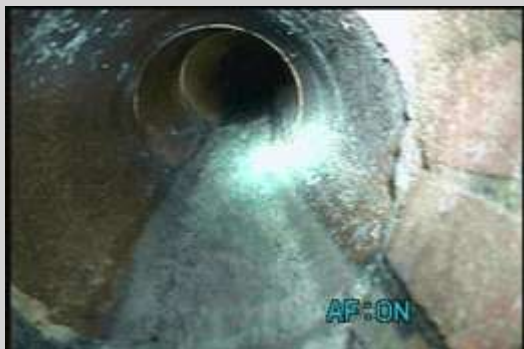
6 O'Clock Inflow

10 in. Circular Gravity Sewer
Pipe In @ 6 O'Clock

couldnt get better pic because of ledge over pipe
